## Inspection of wooden building Villa Annala

The Renovation course 2012 subject in Helsinki is a brief survey of the Villa Annala, Hämeentie st., 154. The two-storey log and wooden-framed building is situated in a park area, and there forit has no plot or official registration number. For this reason, there have been no building permits or records of maintenance works in the building review office. The Parks department has served as the owner, and has organised together with the real estate department the upkeep of the building. The park itself is in excellent condition and the surrounding buildings are all in use. This main building originally built by Konsul Wasenius in 1832 has been empty for over a year. The students have been asked to do a short survey of the building condition, offer alternatives for renovation, and finally give opinions concerning the future of the building. They are working in construction details and architecture team, ventilation and heating team and construction economics groups. The City of Helsinki is unable to give any information concerning the future of the building.

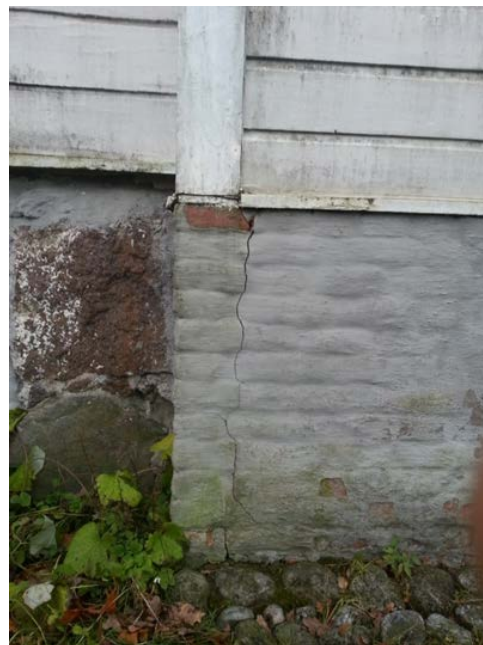
- The joints between the rubble stone has been covered with some kind of plaster which stops the natural ventilation of the foundation;
- Water/humidity damage caused by the leakages and the deficiency of the rainwater pipes that didn't lead the rainwater away from the structure of the house so that infiltrated into the walls, foundations and other essential structures of the building;
- The settlement cracks in the brick-foundation that are probably caused by the uneven settlement of the newer part of the foundation [19,20];
- The lack of ventilation ducts in the foundation to provide the proper ventilation for the first floor and too little crawling space underneath the floor for ventilation ducts to work.

Picture 2. Settlement cracks

- The joints between rubble stone must be cleared out to provide natural ventilation
- Anchor the cracked part of the foundation to the well preserved part to prevent it from collapsing
- Install drainage system to lead the ground and rainwater away from the foundation of this building

- The joints between rubble stone must be cleared out to provide natural ventilation;
- Anchor the cracked part of the foundation to the well preserved part to prevent it from collapsing [14];
- Install drainage system to the ground to lead the ground- and rainwater away from the foundation of this building;
- Excavate the perimeter of the foundation to install thermal- and water insulation for the foundation to prevent further water and humidity damage;
- Drill holes in the foundation wall for the ventilation to provide the crawling space with fresh air;
- Excavate the soil inside the foundation to improve the ventilation of crawling space.

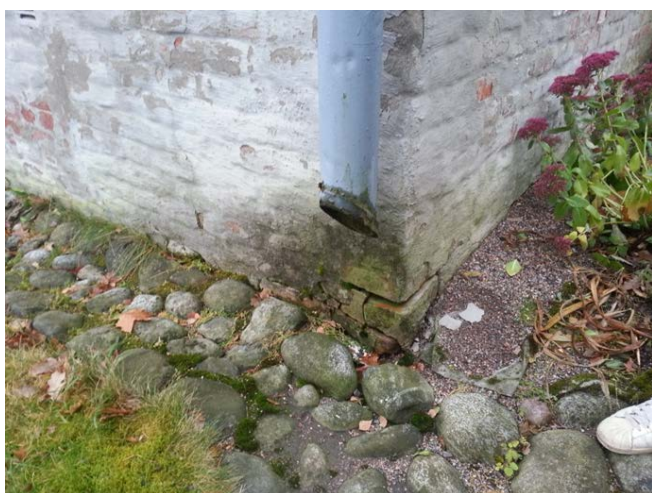
Picture 3. Water damage

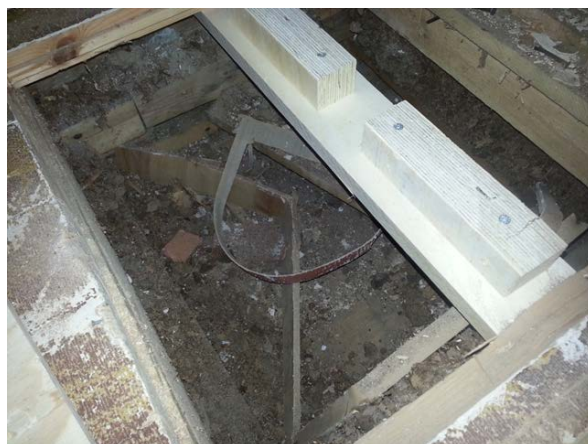
Picture 4. Floors

The structure of base floor is badly ventilated. The insulation of floor is organic material like moss, saw dust and construction waste. There's no air sealing on the insulation. The lack of air sealing has caused the air flow from crawling space through the base floor and has led to energy losses and unpleasant smell to indoor air [3, 4, 8, 17]. There's also garbage stored in crawling space which had caused a bad smell and there's a possibility for mold. Intermediate floors structure is the same as the base floor [2, 3, 15, 19]. Intermediate floor is repaired only in maximum version.

- The old floor planks, PVC sheets and all other interior floor layers are removed. The planks that are in good shape are stored and reused.
- The air seal plastic is installed on the old insulation. Plastic has an overlay on the walls 300 mm high.
- Good shaped and new floor planks are installed back.

- All procedures presented in minimum version are made
- Before installing the air seal plastic the old insulation and possible cardboard is removed. Insulation supporters are checked and the possible broken ones are replaced with new ones.
- The air seal plastic is installed on the supporter planks and the base floor is filled with blown loose wool. The blown loose wool must be compressed properly to avoid the sinking of insulation and ensure its function.

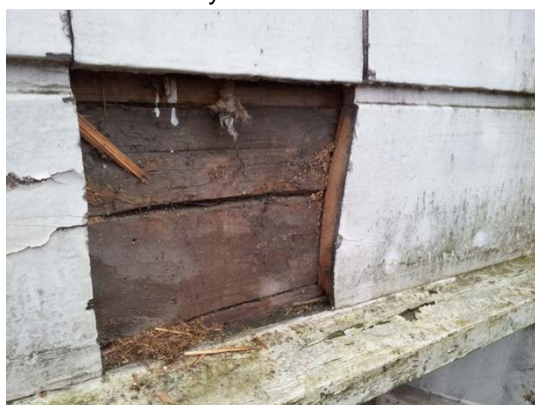
Picture 5. Wooden materials in bad shape

- Removing polluted external cladding. We try to re-use as much old cladding as possible.
- Removing of polluted internal surface.
- Empty walls are renovated as modern walls, structure grows inside.
- Fixing the holes for increasing airtightness, best device to find these holes is thermographic camera.
- Increasing air tightness by adding wind barrier and humidity blocking.

- Adding an ventilative air gap [12]
- 50mm extra thermal insulation inside (cellulose). This is the most difficult part of wall renovating. Movement of cold and moisture has to be calculated and designed very carefully and details of structural joints.
- Removing polluted external cladding. We try to re-use as much old cladding as possible.
- Removing of polluted internal cladding.
- Empty walls are renovated as modern walls, structure grows both inside and outside.
- Fixing the holes for increasing airtightness, best device to find these holes is thermographic camera.
- Increasing air tightness by adding wind barrier and humidity blocking.
- New internal surface, according to Museovirastos recommendations.

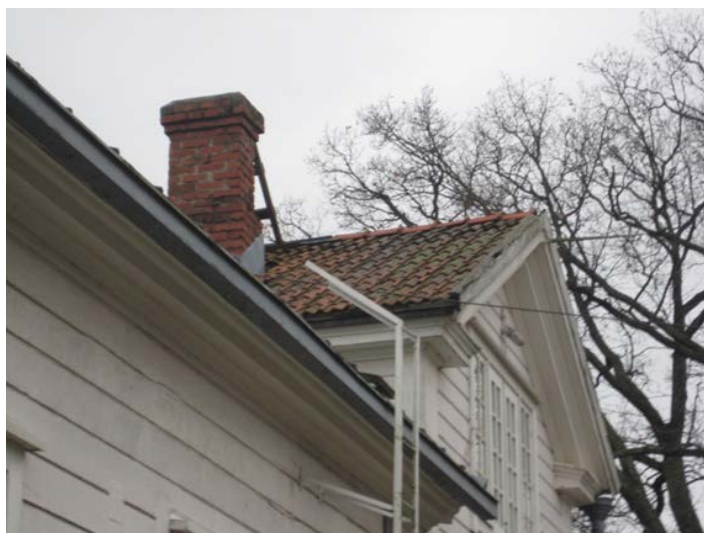
Problem: water leakages, cracks, decaying of timber structure

Picture 8. Bad covering materials

- Provide extra insulation (cellulose wool);
- Change roof covering materials (sheet metal).

- Provide extra insulation (cellulose wool)
- Change roof covering materials (sheet metal).
- Install rain gutters
- Add vapour barrier underneath the thermal insulation layer.
